Infrared Survey Report

**Home of:
Mr. and Mrs. Sample Client
926 Main Street
Your Town, USA 12345**

Survey Information

Survey Report #:	PH-121208-2
Survey date:	12-12-08
Thermographer:	Peter Hopkins
Weather:	Sunny
Outdoor temperature:	45 °F
Indoor temperature:	75 °F
Temp diff In-Out (Δt):	30 F °

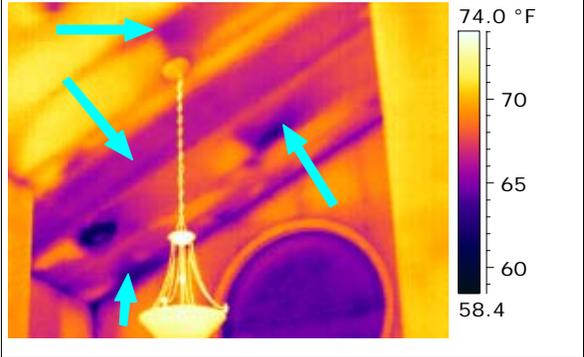
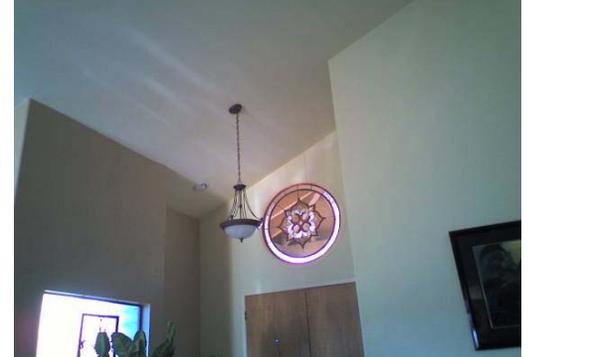
<p>Date 12/12/2008</p>	<p>Image.File name IR_0639.jpg</p>
<p>Location: Entry Area Where: Ceiling Condition: Appears to be missing or loose insulation Recommendation: We recommend further investigation of this area and repair as needed.</p> <p>CORRECTED BY: _____ DATE ____-____-_____</p>

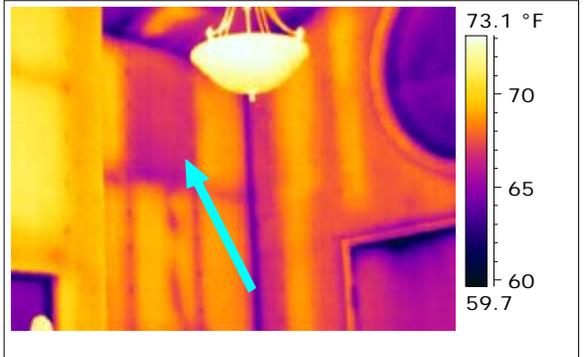
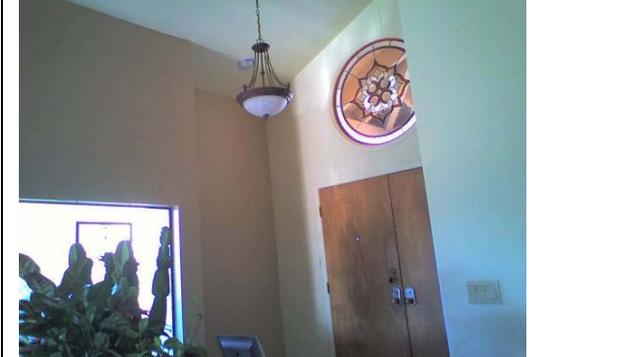
<p>Date 12/12/2008</p>	<p>Image.File name IR_0641.jpg</p>
<p>Location: Entry Area Where: Right wall Condition: Appears to be missing or loose insulation Recommendation: We recommend further investigation of this area and repair as needed.</p> <p>CORRECTED BY: _____ DATE ____-____-_____</p>

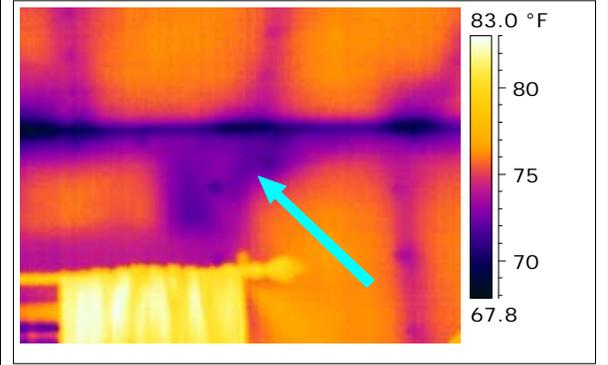
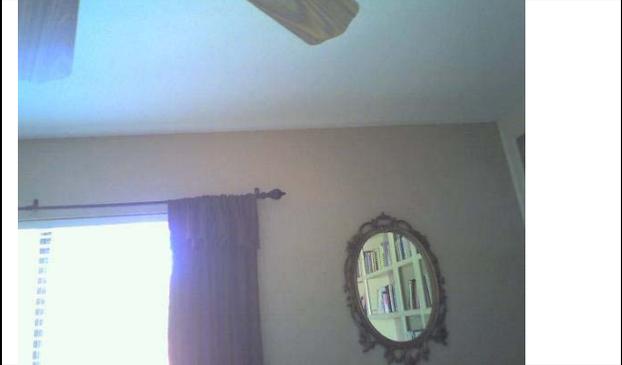
<p>Date 12/12/2008</p>	<p>Image.File name IR_0672.jpg</p>
<p>Location: Guest Bedroom 2 Where: Left wall Condition: Appears to be missing or loose insulation Recommendation: We recommend further investigation of this area and repair as needed.</p> <p>CORRECTED BY: _____ DATE ____-____-____</p>

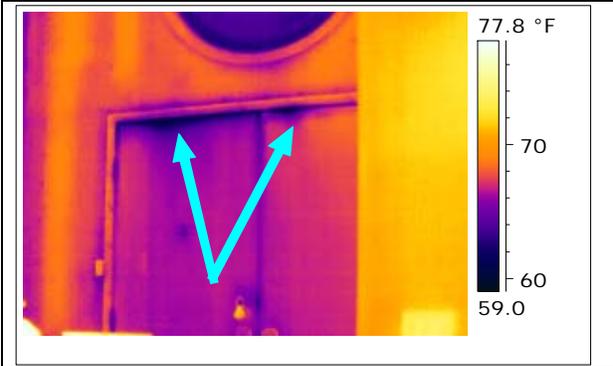
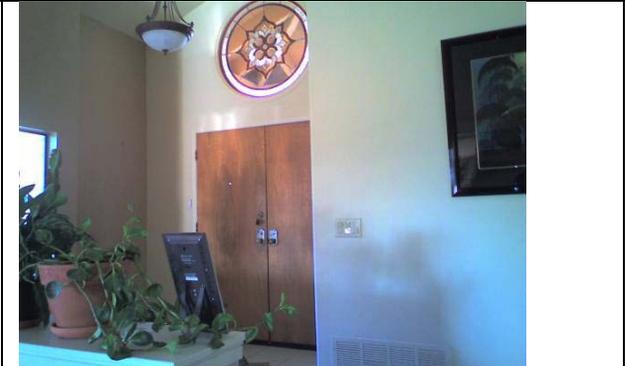
<p>Date 12/12/2008</p>	<p>Image.File name IR_0645.jpg</p>
<p>Location: Entry Area Where: Exterior door Condition: Weatherstripping at exterior door(s) appears to have air infiltration due to gaps or missing sections. Recommendation: We recommend further investigation of this area and repair as needed.</p> <p>CORRECTED BY: _____ DATE ____-____-____</p>

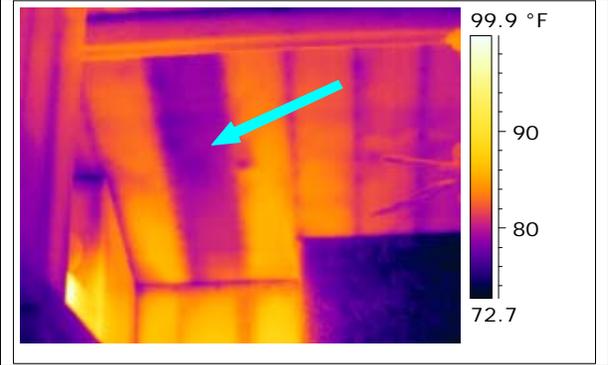
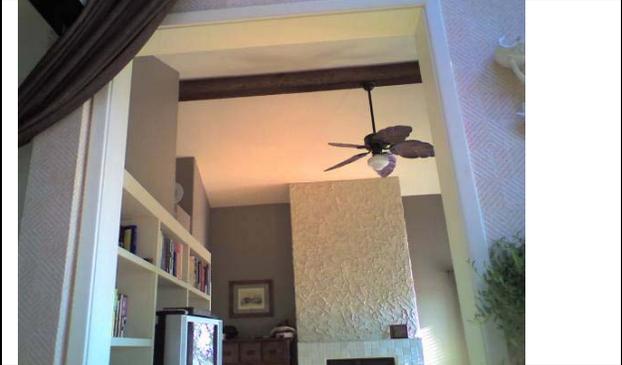
<p>Date 12/12/2008</p>	<p>Image.File name IR_0653.jpg</p>
<p>Location: Master Bedroom Where: Ceiling Condition: Appears to be missing or loose insulation Recommendation: We recommend further investigation of this area and repair as needed.</p> <p>CORRECTED BY: _____ DATE ____-____-____</p>

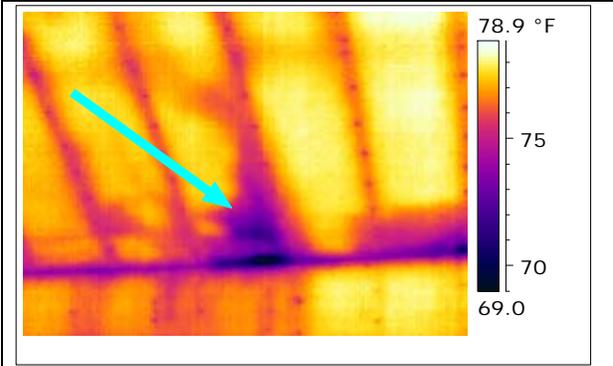
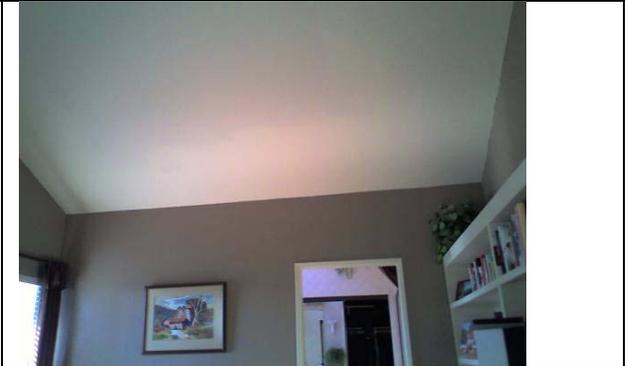
<p>Date 12/12/2008</p>	<p>Image.File name IR_0655.jpg</p>
<p>Location: Master Bedroom Where: Ceiling Condition: Appears to be missing or loose insulation Recommendation: We recommend further investigation of this area and repair as needed.</p> <p>CORRECTED BY: _____ DATE ____-____-____</p>
